# TECHNICAL INSPECTION REPORT

⑥ OPERATION CROSSROADS.  
U.S.S. TUNA (SS203)

TEST BAKER [U] ⑧

OPERATION CROSSROADS

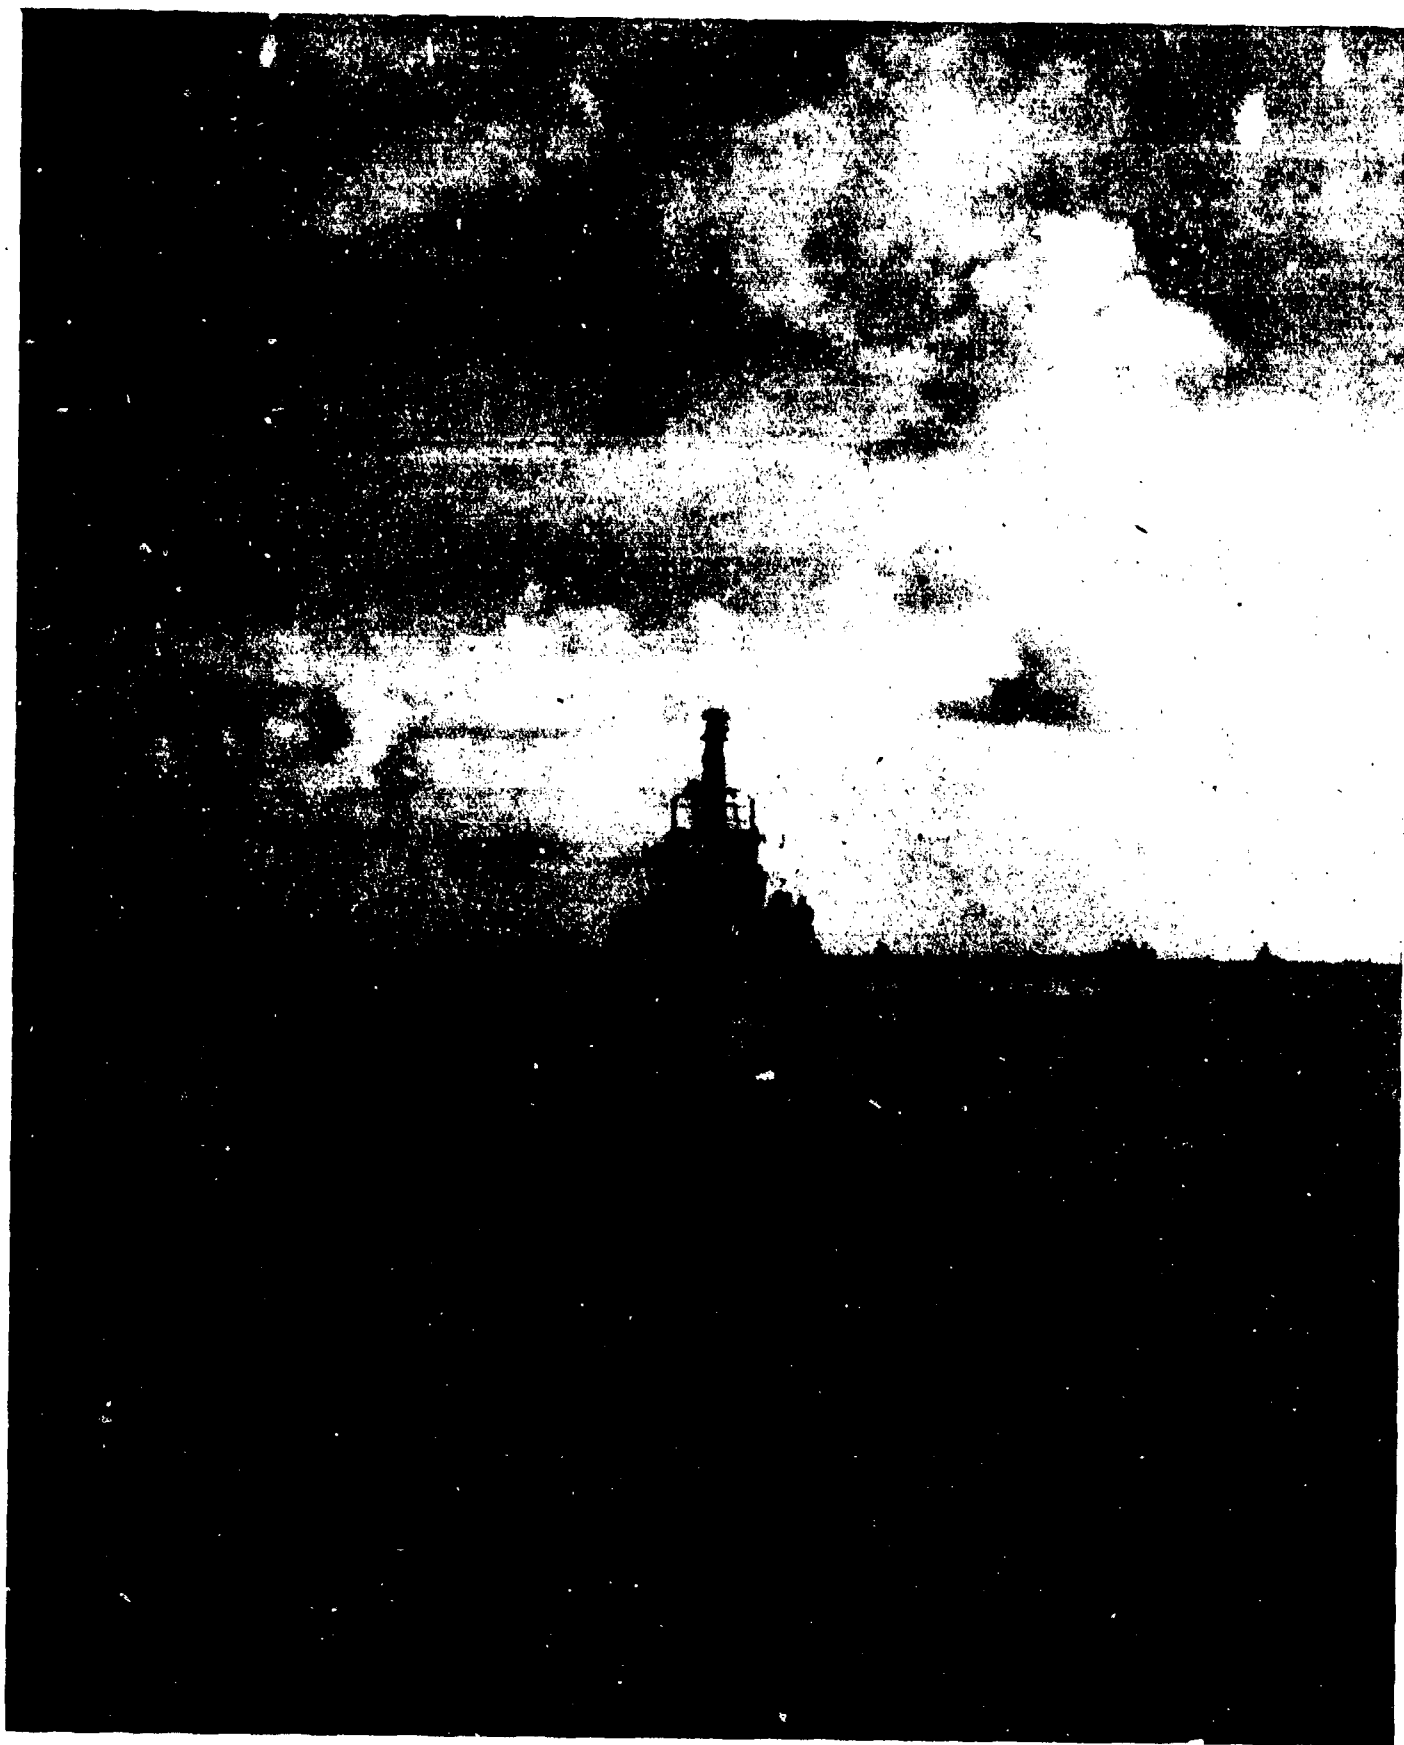
ABCR-227-290-52. General view from ahead.

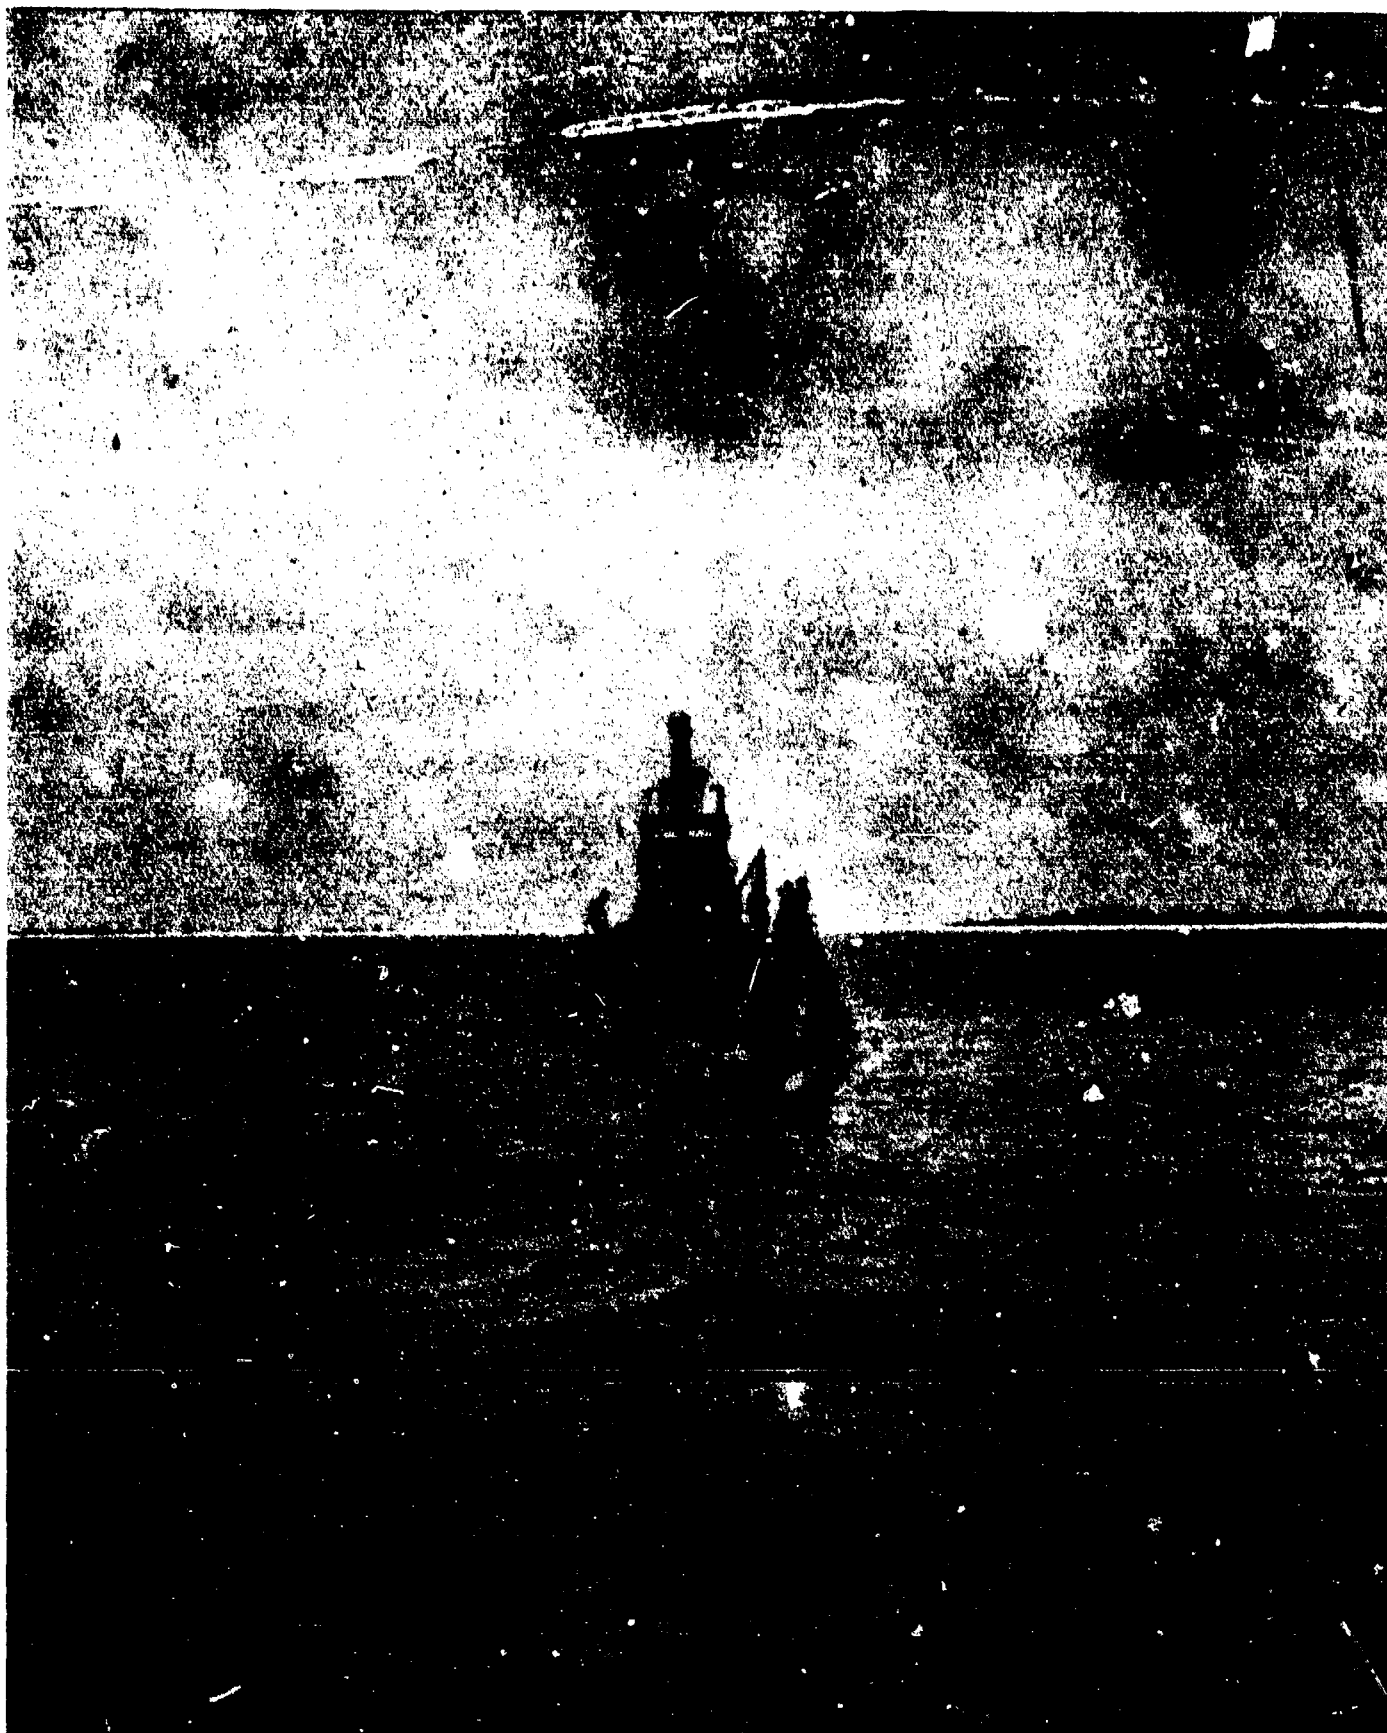
ABCR-227-290-48. General view from astern.
